The Role of a Hurricane in the Expansion of Disturbances Initiated by Motor Vessels on Seagrass Banks

Paula E. Whitfield, W. Judson Kenworthy, Kamille K. Hammerstrom, and Mark S. Fonseca

WHITFIELD, P.E.; KENWORTHY, W.J.; HAMMERSTROM, K.K., and FONSECA, M.S., 2002. The role of a hurricane in the expansion of disturbances initiated by motor vessels on seagrass banks. *Journal of Coastal Research*, SI(37), 86-99. West Palm Beach (Florida), ISSN 0749-0208.

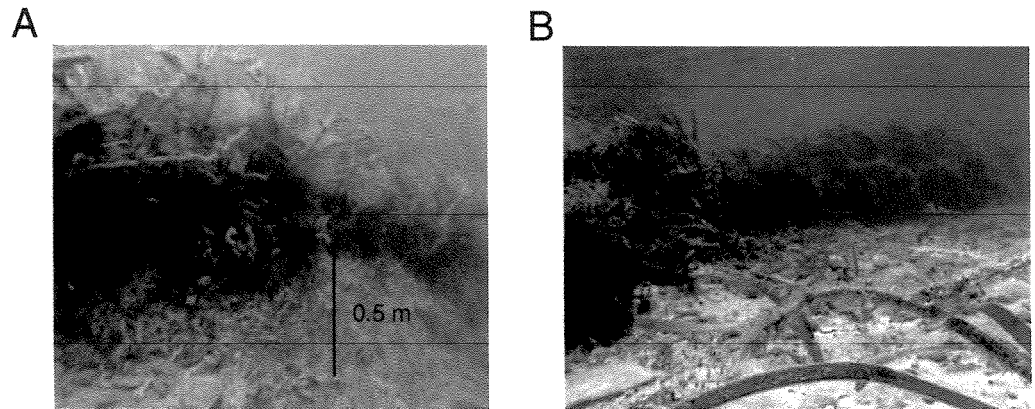
Figure 1. (A) Photograph of a deep blowhole injury margin created by a motor vessel grounding. Scale bar is approximately 0.5 m. Vertical edge shows broken rhizomes and unconsolidated *Porites porites* rubble. (B) Photograph of a slightly shallower injury. Broken rhizomes are shown at the injury margin on left. Right side of photograph is mainly unconsolidated *P. porites* rubble.

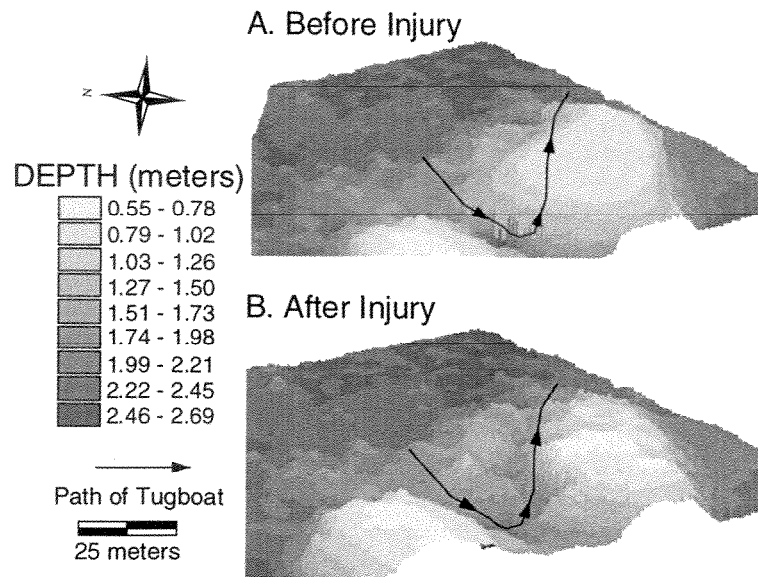
site in November 1998 by Environmental Development Consultants Corporation (EDC, 1998). Figure 3A is the original banktop bathymetry recreated from aerial photography, and Figure 3B illustrates the bathymetric characteristics of the resulting injury. Although some of the unconsolidated sediment was redistributed back into the channel after the hurricane, the injury was still a very distinct morphological feature of the bank.

Figure 3. Three dimensional graphic of the bathymetry data for the *Captain Joe* site before the injury (A) and after the injury (B). Black line with arrows shows the path of the tugboat across the bank.

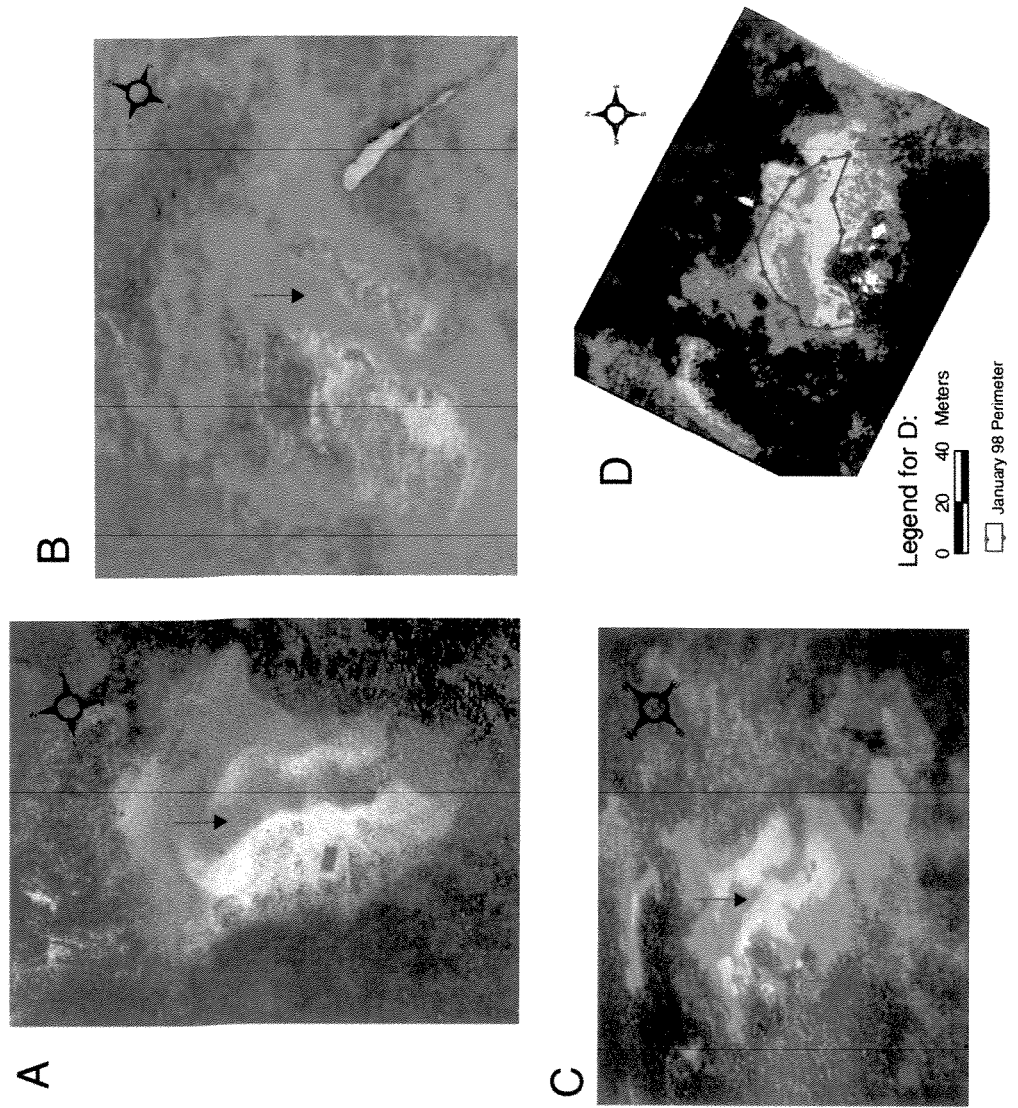
The area of seagrass damaged by the initial physical disturbance was 7,363 m², as determined from the 1993 aerial photograph (Figure 4A). The footprint for the most severely damaged area remaining in January 1998 was 1,576 m². Thus, after 4.5 years, 5,787 m² of the site displayed some degree of recovery. However, after Hurricane Georges, the area of most severe damage increased from 1,576 m² to 2,514 m². The color aerial photographs (Figure 4) show a time series beginning with the original injury in which 100% of the seagrasses was lost (Figure 4A), the condition 4.5 years later (Figure 4B), and finally, the injury shortly after the hurricane (Figure 4C). Following the storm, seagrasses and macroalgae were removed from the trench and berms, setting back the recovery process. The recovery setback due to the hurricane is evident in the georeferenced color aerial photograph (Figure 4D). The white, fan-like formations extending outside the red line represent damage caused by scouring and redistribution of sediments during the hurricane. The unconsolidated sediments on the berms and in the trench were relocated into fans that extended to the east of the site.

Figure 4. Oblique time series color photographs of the *Captain Joe* injury. In May 1993 (A), February 1996 (B), in October 1998 after Hurricane Georges (C). Georeferenced vertical photograph of the site two months after the hurricane (D). The lightest parts of the photographs are the shallow berms separated by a deep, 2–3 m trench. The arrows in each photograph illustrate the location of the trench between the north and south berms. The darker areas on the north and south berms represent recovery by seagrasses and macroalgae (C). The red dotted line represents the January 1998 perimeter (D). The white fan formations that extend outside of the red perimeter represent damage sustained due to the hurricane.

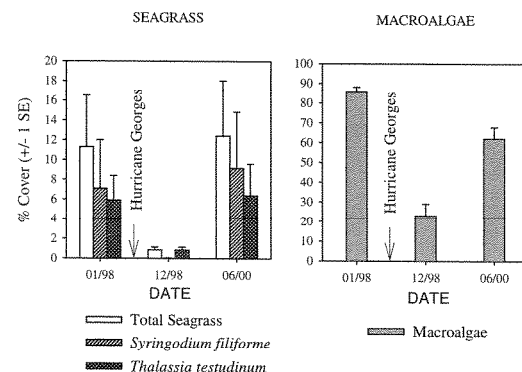
forme, *T. testudinum*). Within the most severely injured perimeter identified and mapped in January 1998, the percent cover of seagrass and macroalgae amounted to 11.3% (SE = ± 5.2) and 85.4% (SE = ± 2.7), respectively (Figure 5). *Thalassia testudinum* represented 5.9% (SE = ± 2.5) and *S. filiforme* 7.1% (SE = ± 4.9) of the seagrass recovery.

Three months after the hurricane, in December 1998, the seagrass and macroalgae cover had declined to < 1% (SE ± 0.29) and 22.9% (SE ± 6.2), respectively. The site sustained almost a complete loss of seagrasses with the exception of two *T. testudinum* seedlings, possibly new recruits. During the final survey in June 2000, 21 months after the hurricane, total seagrass cover was 12.4% (SE = ± 5.6), and macroalgae cover was 62% (SE = ± 6.2). Seagrasses had recovered to their original pre-hurricane values, and the macroalgae to within 20% of pre-storm coverage, although the coverage was still much lower than that on adjacent, undisturbed banks.

Figure 5. Biological data collected at the *Captain Joe* site, once before the hurricane (01/98) and twice after the hurricane (12/98 and 06/00).

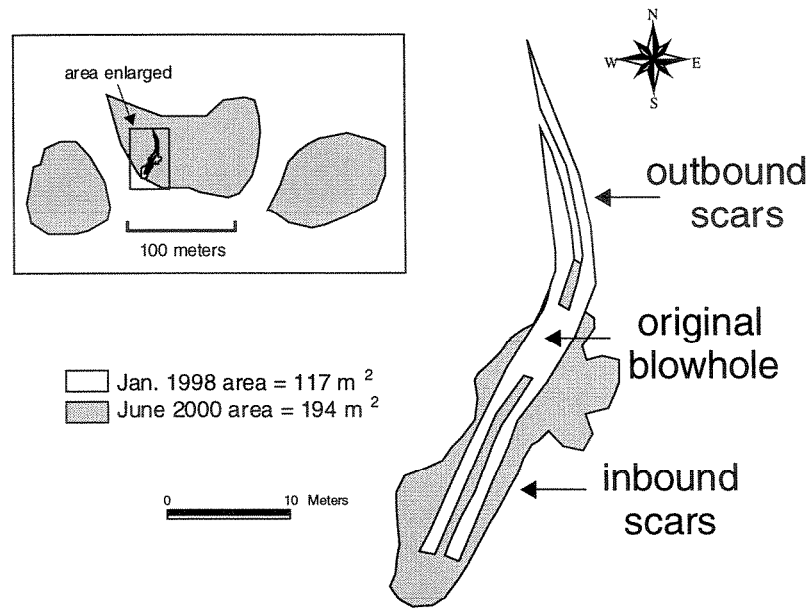
In January 1998, the injured area associated with the grounding was 117 m² (Figure 6). In December 1998, 2 months after Hurricane Georges, the individual inbound propeller scars were no longer discernible and were replaced by one large excavation hole in the seagrass bed. The area of the original injury had increased to 194 m² in June 2000, an expansion of 65%.

Figure 6. The *Broadbill* injury perimeters from January 1998 and June 2000 overlaid. The area enclosed in the square represents the location of the injury on the bank.

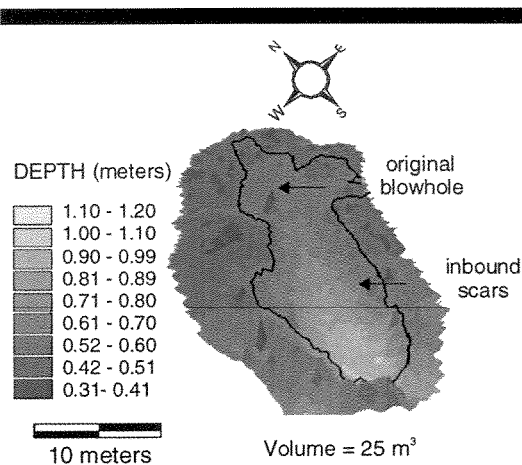
The bathymetry of the site in June 2000 revealed a 1 m deep excavation where the original propeller scars were before the hurricane (Figure 7). The northern portion of the original blowhole appeared to have regraded, and the outbound propeller scars had been recolonized by seagrasses and macroalgae. However, the rest of the injured area appeared to be expanding, as evidenced by the perimeter comparisons between the two time periods (Figure 6). A total amount of 25 m³ of sediment was removed from the banktop by June 2000 due to the combined effects of the injury and the hurricane.

Figure 7. Three dimensional graphic of the bathymetry data for the *Broadbill* injury. The arrows point to the locations of the original inbound scars and blowhole. The volume of sediment scoured out was 25 m³.

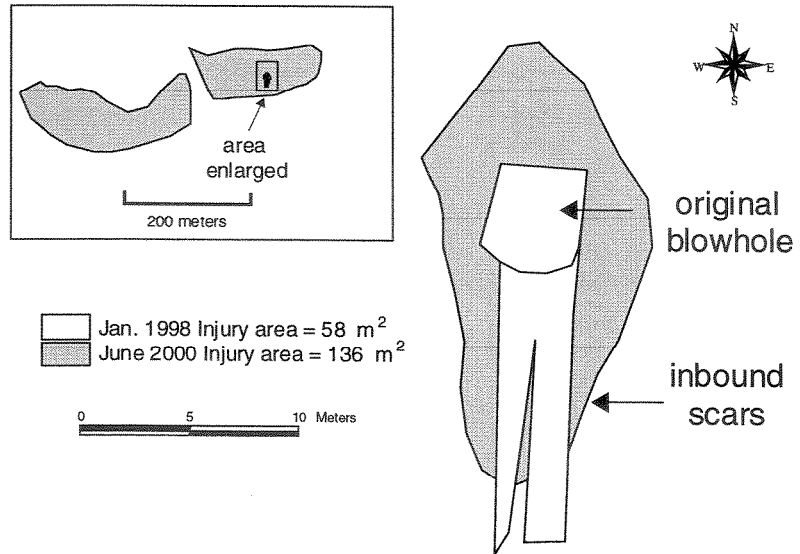
During the first survey in January 1998, prior to the hurricane, the injured area was 58 m² (Figure 8). The circular excavation measured 4.3 m \times 2.9 m, and was 0.75 m deep. Twenty-one months after the hurricane (June 2000), the injured area was 136 m², more than twice the area of the original injury. The changes were similar to those observed at the *Broadbill* site. The blowholes and the propeller scars had coalesced into a large polygonal-shaped excavation. The bathymetry data illustrate the extent of the sediment scour that occurred due to the hurricane (Figure 9). The whole injury in June 2000 was 1–1.5 m deep. Approximately 65 m³ of sediment had been excavated from the banktop as a result of the combined effects of the injury and the hurricane.

Figure 8. The Twin Screw injury perimeters from both time periods, January 1998 and June 2000. The arrows point to the locations of the original inbound scars and blowhole. The area enclosed in the box is the location of the injury on the bank.

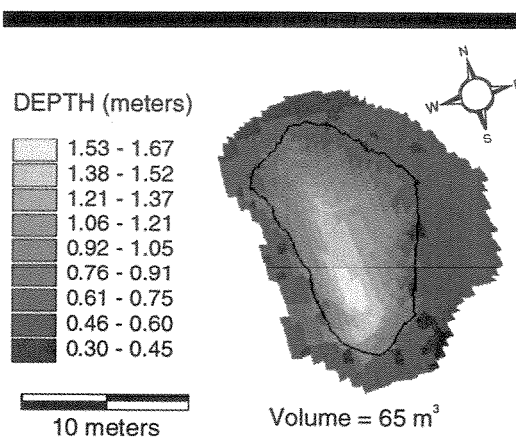
Figure 9. Three dimensional graphic of the bathymetry data for the Twin Screw injury. The area scoured from the banktop is 65 m³.

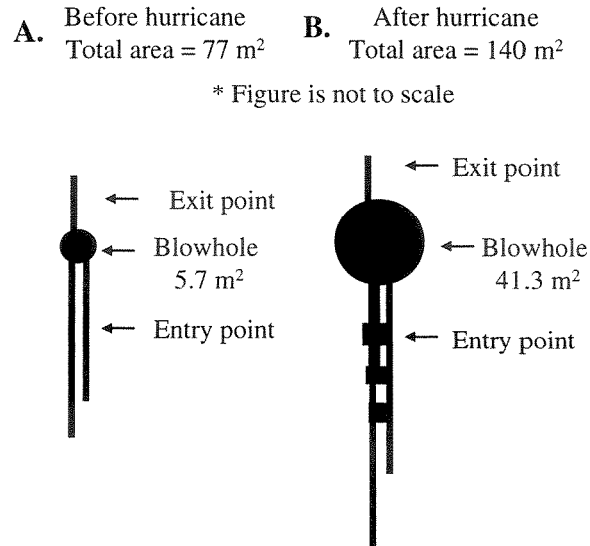
The area of the original injury was 77 m² in September 1998 prior to the hurricane. Eight months after Hurricane Georges (May 2000), the area had doubled to 140 m² (Figure 10). This site appeared to have deteriorated in a manner similar to the

Broadbill and the Twin Screw case studies. The blowhole was seven times larger, and the island of seagrass between the twin propeller scars had also been blown out and enlarged due to the formation of new excavation holes in the inbound track.

Figure 10. Injury area for the 19 m motor yacht injury before (A) and after (B) the hurricane.
